# Dampco

## MOISTURE & MOULD REMEDIATION, IDENTIFICATION & REPAIR EXPERTS

**PROPERTY OVERVIEW - address here**

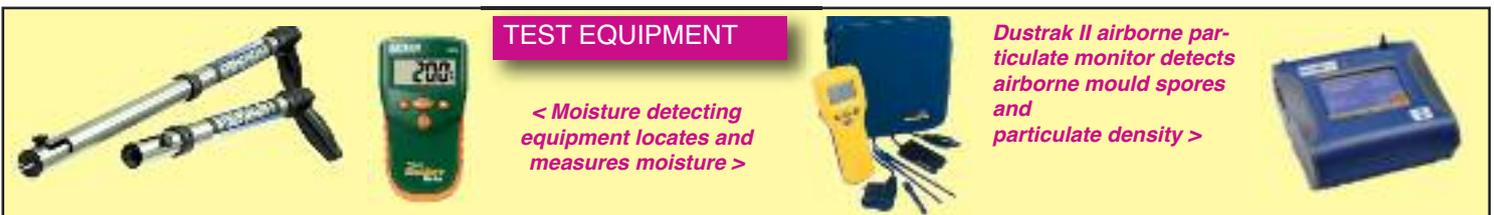
**TEST EQUIPMENT**

*< Moisture detecting equipment locates and measures moisture >*

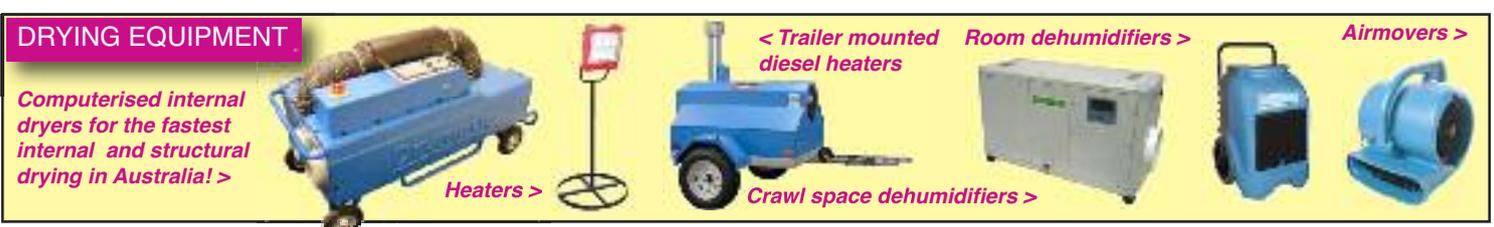
**DRYING EQUIPMENT**

*Computerised internal dryers for the fastest internal and structural drying in Australia! >*
